Edgefield Gardens and Golf Course

Drainage Ditch Stabilization Project

Troutdale, Oregon; Summer 2007

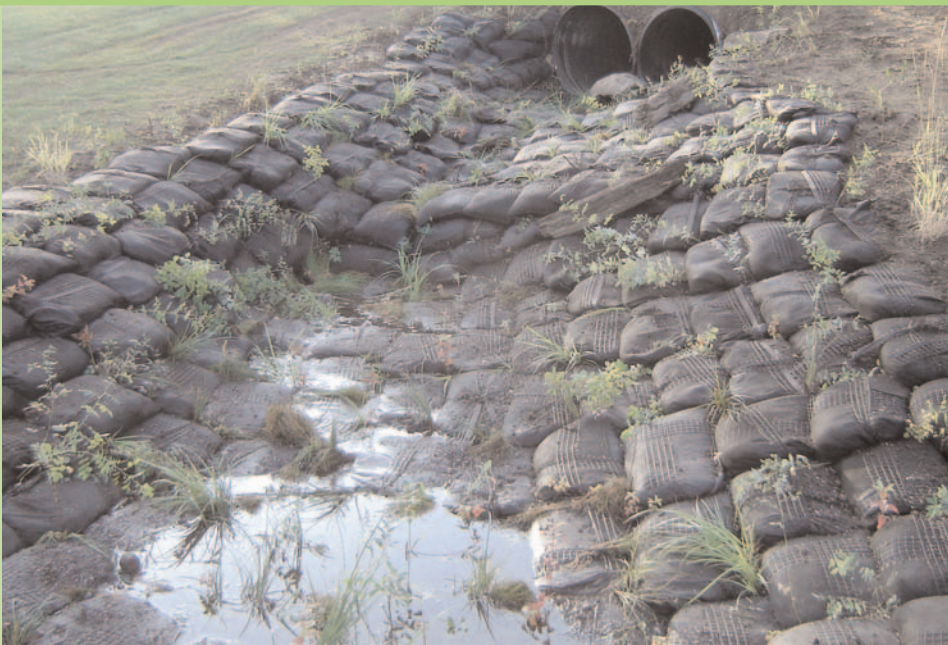
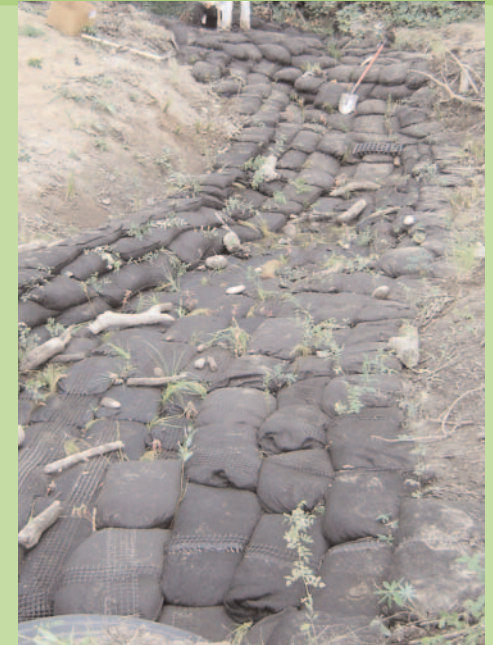
In 1997, a residential development was built upslope from this golf course drainage ditch. It began to erode, but because the ditch was filled with invasive species such as Blackberry and Reed Canary Grass, the erosion was not visible.

When the non-native plants were removed to create a new golf course hole, the erosion was evident – in some places more than four feet deep, all the way down to the hard clay bottom.

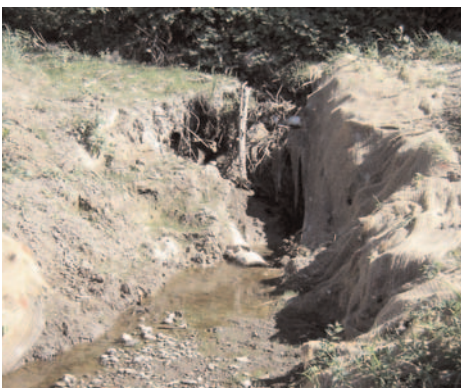
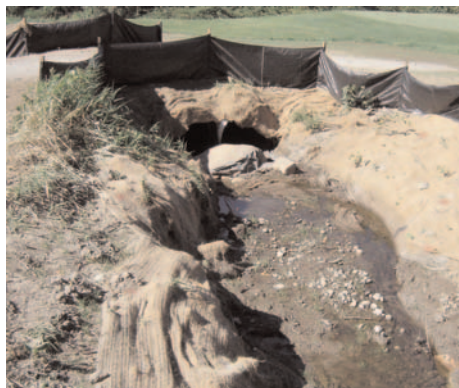
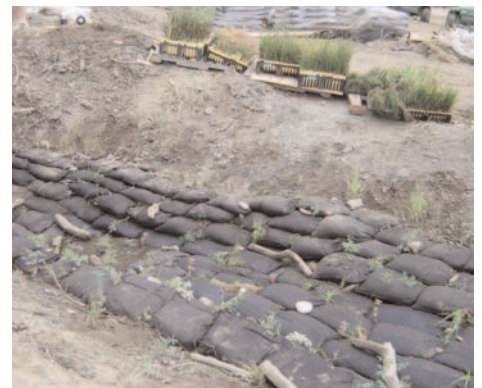
The Envirolok Vegetated Retaining Wall system was used for both the sides and bottom of the ditch. It was installed and woven together with bag stabilizer fabric to prevent rushing water from compromising the structure.

The use of foundation bags in the bottom of the channel provided the 'anchor' to hold all the bags together. The anchor bags were embedded to minus 8".

The entire system was hydroseeded.

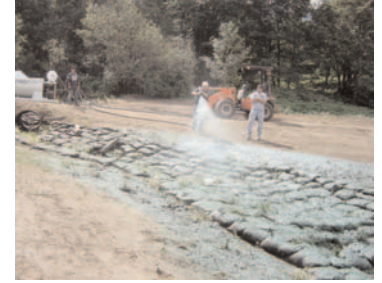
The ability of the Envirolok Vegetated Retaining Wall System to withstand flashy storm events solved a persistent and costly erosion control issue. Storm event erosion is absolutely zero since the installation.

The new ecosystem is growing desirable native species that provide habitat for birds, butterflies and animals. The native vegetation also improves the aesthetics of the golf course. The benefits of the low-maintenance vegetation are both ecological and financial.
