# Lake Waubesa, Wisconsin

Residential Shoreline Seawall Replacement • Stormwater Management

McFarland, Wisconsin; Summer 2007

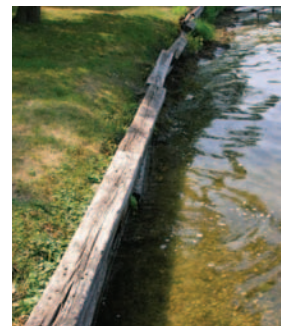
*Existing railroad-tie wall*

In early August, 2007, a homeowner on Lake Waubesa near Madison, Wisconsin contacted Agrecol Corporation about their Envirolok Vegetated Retaining Wall System. The homeowner wanted to replace a failing lake wall with an environmentally-friendly shoreline. The old wall was built with creosote railroad ties.

In late August of 2007, near record rain caused flash floods, mudslides and high water all over the Midwest. The seawall failed completely, breaking apart and drifting into the lake. The water on Lake Waubesa was so high that the county suspended all recreational activities on the lake.

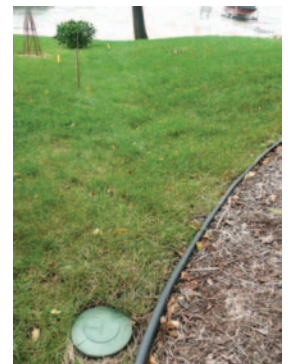
*Stormwater pipe*

- A stormwater discharge pipe in the backyard, which collects stormwater from the upper end of the property, was undirected, causing erosion in the backyard and resulting in pockets of standing water.
- The impervious runoff came from these sources: the roof of the house, half of the run-off from the neighbors roof, the patio, the surrounding city streets, and the turf areas of the lawn.

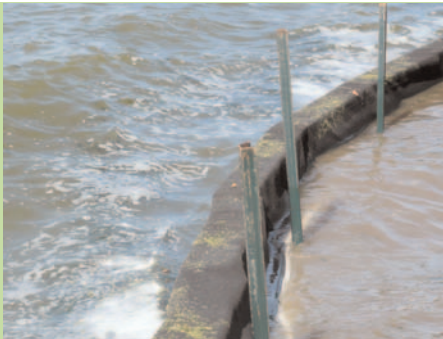
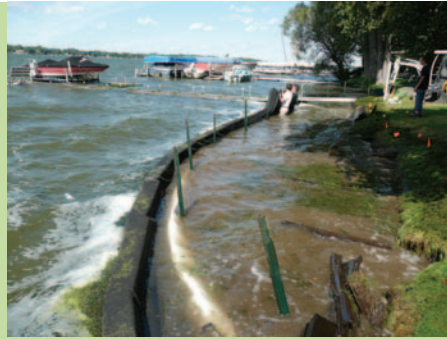
A floating turbidity barrier was installed to protect the lake during the removal of the old railroad tie wall; it prevents sediment and phosphorous into the lake during construction.

*Turbidity barrier*

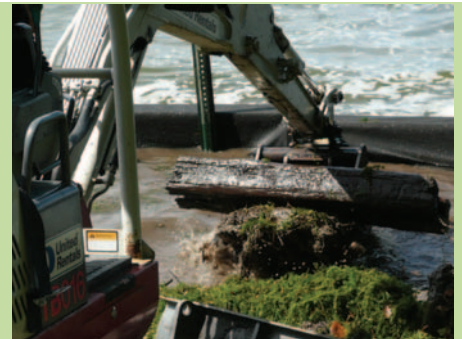
*Removing the old wall*

The bottom of the lake was excavated to a depth of 6 inches to allow for embedment and the bank was excavated to a 4:1 slope to facilitate the install. This work was done with a rubber tracked mini-excavator.

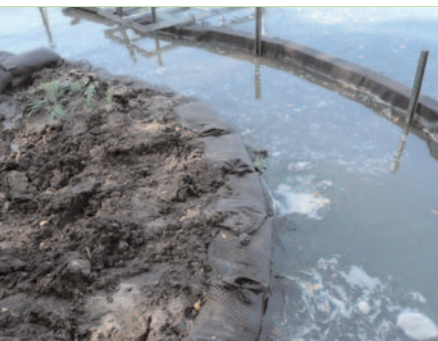
The embedded foundation course of the retaining wall, complete with bag stabilizing material, was laid perpendicular to the bank in the excavated area of the lake bed.

The second and third courses were laid parallel to the shoreline using cinching, twining and spiking to create

the strongest structure possible. The drain tile with sock was installed behind the third course to alleviate hydrologic pressure that may have been present behind the wall. The drain tile was back-filled with free draining sand.

The subsequent courses were laid using the cinching, twining and spiking methods, and as with all of the courses, the bags were tamped.

*Building the wall*

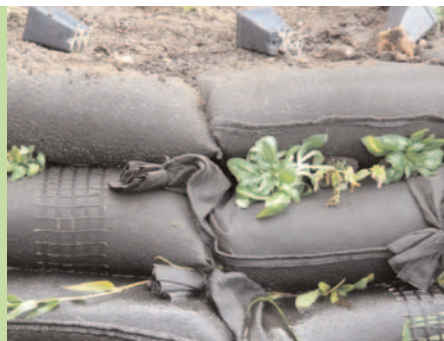
During the construction of each course, live plants were installed between the bags. The wall below the waterline was vegetated with emergent zone native plants. As the wall progressed upwards out of the water, they changed to mesic plants.

*Planting the courses*

Approximately six-hundred native wetland plants were planted along the new wall.

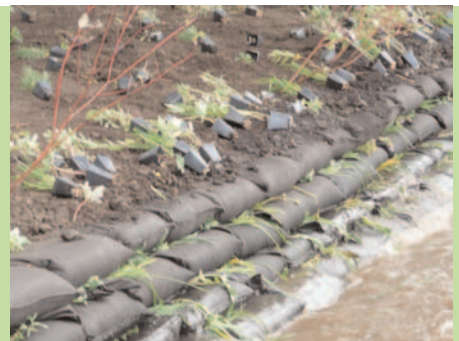
*Completed wall*

Because of the high water, most of the construction had to take place below water, though still short of the ordinary high water mark. A sixty-five foot by three foot sand/soil bag wall was constructed, and three feet of the wall was embedded below the waterline

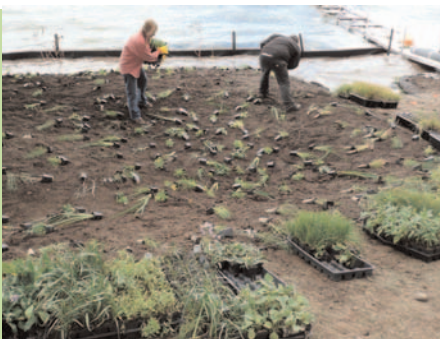
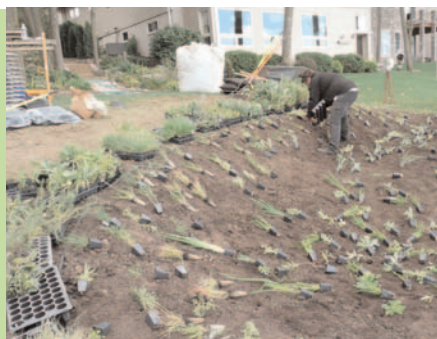
A Rainwater Garden and Shoreline Buffer Zone was constructed downslope from the stormwater discharge pipe. A 1,000 square foot garden was planted and approximately 1,800 native plants were planted.

The plants were installed according to Zones. Those plants that are more suited to a wet environment were placed at the bottom of the slope, graduating to mesic species at the rise of the slope.

Planting the rainwater garden

The rainwater garden and native buffer will capture this water and allow it to collect and filter to groundwater, before it enters the lake.

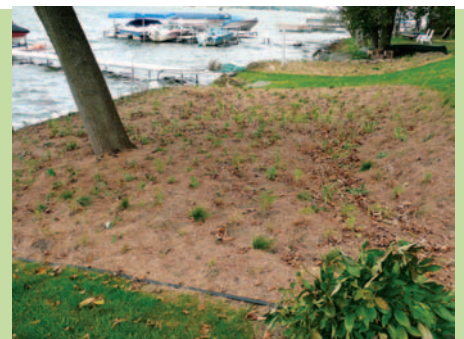
Two weeks after planting
